**DEPARTMENT OF TRANSPORTATION**

Contract #: 04-0120F4Cty: SF/ALA Rte: 80 PM: 13.2/13.9File #: 1.28**WELDING INSPECTION REPORT****Resident Engineer:** Casey, William**Address:** 333 Burma Road**City:** Oakland, CA 94607**Report No:** WIR-028361**Date Inspected:** 26-Aug-2012**Project Name:** SAS Superstructure**OSM Arrival Time:** 700**Prime Contractor:** American Bridge/Fluor Enterprises, a JV**OSM Departure Time:** 1530**Contractor:** American Bridge/Fluor Enterprises, a JV**Location:** Jobsite**CWI Name:** Berry Drake**CWI Present:** Yes No**Inspected CWI report:** Yes No N/A**Rod Oven in Use:** Yes No N/A**Electrode to specification:** Yes No N/A**Weld Procedures Followed:** Yes No N/A**Qualified Welders:** Yes No N/A**Verified Joint Fit-up:** Yes No N/A**Approved Drawings:** Yes No N/A**Approved WPS:** Yes No N/A**Delayed / Cancelled:** Yes No N/A**Bridge No:** 34-0006**Component:** OBG 13 / 14 West**Summary of Items Observed:**

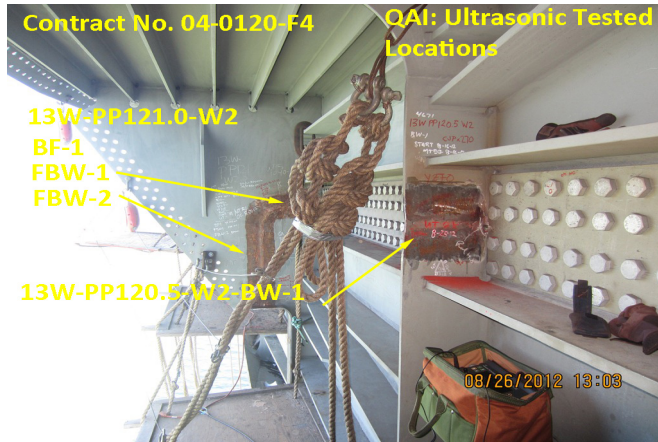
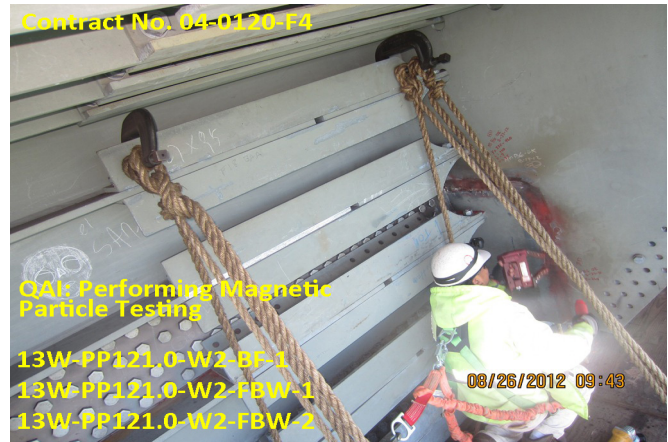
This QAI inspector performed UT of approximately 10% of the area previously tested and accepted by ABF Quality Control personnel. This QAI Inspector generated an UT report for this date. All components were verbally requested by QC personnel; Mr. Bonifacio Daquinag Jr. The member(s) is/are identified as OBG 13W Vertical Plate Stiffener Splice, Floor Beam Web Splice, WT Flange and Web Splice. The weld designations reviewed are as follows

Unless noted otherwise, all work observed on this date appeared to be in general compliance with the contract documents at the time of observations.
